Church of the Holy Spirit

Location Sv. Duh overlooking Dravograd

Time of origin end of the 16th, beginning of the 17th century

Time of restoration 1993–1997

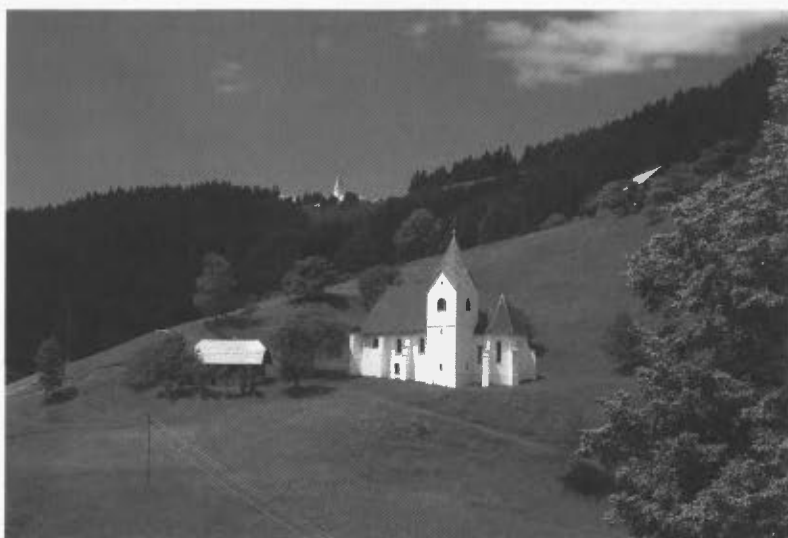
◀ Wooden painted ceiling before the renovation. “On account of moisture permeation, microorganisms and other physical damage the wood had severely rotted...”

During her writing of the book *Painted Wooden Ceilings in Slovenia* Dr. Nataša Golob had established, as early as 1984, that the ceiling was greatly endangered on account of the instability of the church architecture and partial decay caused by the damaged roof. In September 1992 the church was stabilized and the rifts between the ceiling boards had no longer increased, yet on account of moisture permeation, microorganisms and other physical damage the wood had severely rotted, putrefied and become brittle and breakable. The adhesive had disintegrated, the layer of colours had faded or been completely washed out. In the south nave the ceiling had slanted by 20-30cm, while the ceiling in the north nave completely rotted due to soaking.

inspection Dr. Nataša Golob proposed the procedure of the restoration, namely the removal of all the boards of the ceiling and choir and their subsequent cleaning, impregnation, restoration of the ornamented painting and final replacement. Yet the beginning of the restoration clearly showed the impossibility of restoring the original state of the ceiling through conservation only. Therefore the decision to perform the reconstruction of the entire ceiling was taken, with the exception of the choir banister and the ceiling above the choir.

The ceiling had been made in pine-wood and painted in five shades of colour: brick-red, grey-blue, ochre, green and white. Colour stripes were completed by 20 geometric motifs of the late Gothic style executed by stencils in black. The original painted boards were taken off for the restoration and subsequently cleaned, strengthened and stacked in the attic of the church in their original order as they had been positioned on the ceiling.

The original paint was best preserved under the covering boards, therefore the reconstruction followed the model of the colours there and the copy of the ceiling at a scale of 1:1. That was the only possible method of copying the original with all its faults committed by the original artisans. The signed and dated cross-boards located between the second and third sections in all three naves were impregnated, strengthened, and finally replaced as documents of their time.

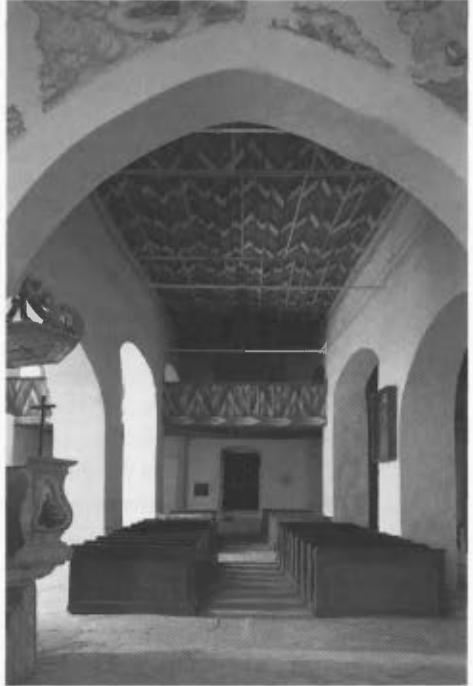
View of the main nave with the reconstructed wooden ceiling. "The ceiling is, according to its superficies, the largest painted wooden ceiling in Slovenia..."

The reconstructed ceiling in its vivid "flickering" scale of colours has thus been revived to give its old appearance.

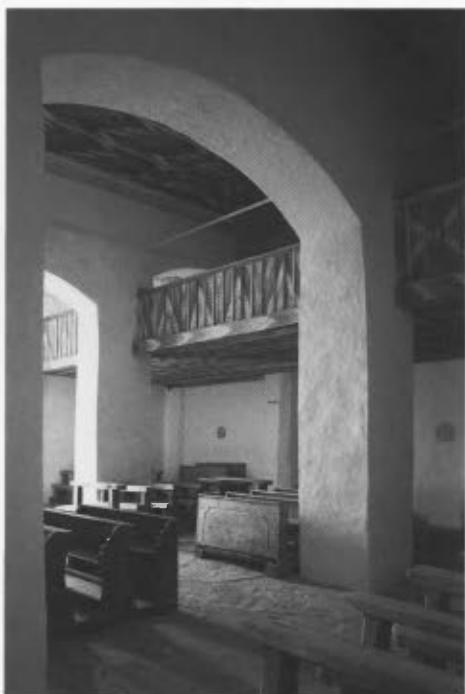
View of the renovated wooden choir. "Therefore the decision to perform the reconstruction of the entire ceiling was taken, with the exception of the choir banister and the ceiling above the choir..."
