Archaeological Site of Ajdna

IRN 564

Location	Potoki near Žirovnica
Time of origin	6th century
Time of restoration	Since 1981
Chief Conservator	Milan Sagadin and assistants Ivan Bogovčič, Jernej Hudolin, Franc Vardjan
Visits	Access from the village of Potoki or from the valley of Završnica

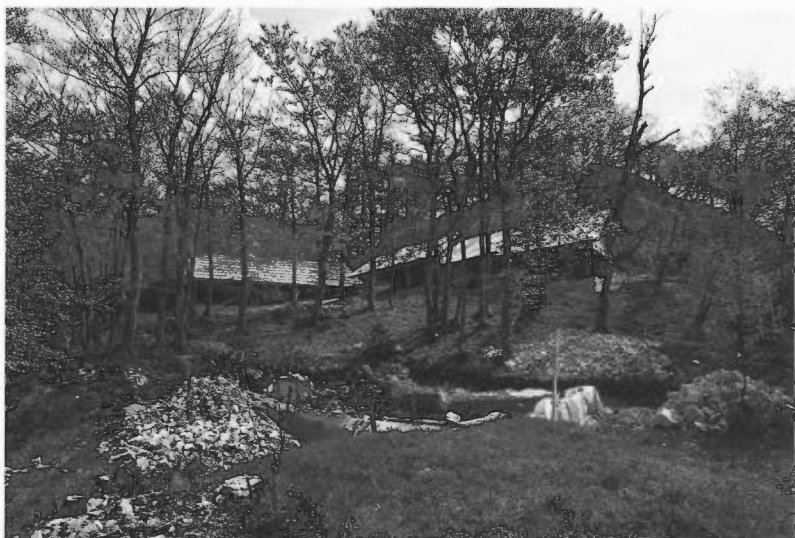
Archaeological excavations in 1996. "Intense investigation of settlements of that period discovered the exceptional range of changes in the settlement picture of the south-eastern Alpine region..."

Systematic archaeological research began in 1976 when the first trial boreholes were initiated by Andrej Valič from the Gorenjski Museum in Kranj. The old Christian church was discovered in the first year and it was excavated in several stages in 1983, after the excavation of the entrance shed. An additional 5 structures have been completely excavated so far, apart from the church, and two further ones only partly excavated.

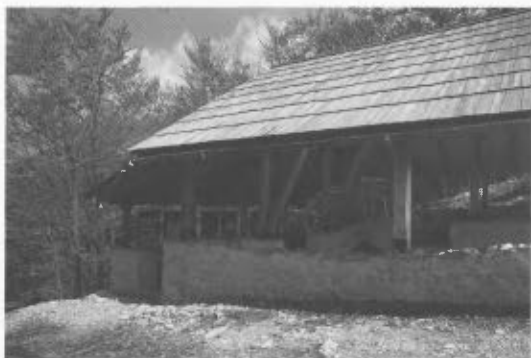
Presented remnants of the old Christian church. "The church was presented to such an extent that it can again serve its original purpose..."

The principal building of the settlement was the old Christian church. It belonged to the type of Aquileian architecture which was common in the 5th and 6th centuries in the entire region belonging to the church organization of the Patriarchate of Aquileia. It was a simple building with a rectangular floor plan, divided at one third of its length into the higher eastern part (presbytery) intended for the clergy, and the lower western part (nave) for the congregation. There was a lean-on shed in front of the entrance. A semi-circular bench for priests leaned on the eastern wall of the presbytery, together with a prominent throne for the holder of the service. A stone-built altar stood in

Investigations proved that the church in its present appearance was constructed in two or three phases. The first building with a lean-on wooden shed on the western side was almost destroyed in an unknown disaster. In the second phase it was built with somewhat thinner walls; the shed was abandoned, the main entrance on the axis of the church was walled-in, and another room was added on the northern side with the entrance through it. The room was divided into two parts, and the passage between them was built up in the third phase. The second phase can be dated on the basis of the central grave next to the walled-in entrance as belonging to the first half of the 6th century. There were 11 graves discovered in the church itself, in the entrance shed on the western side and in both side rooms on the northern side. Those were the so-called privileged burials and not the burial ground of the entire population of the settlement, which has not been discovered yet. Two late Antiquity construction phases were discernible in residential dwellings to the south-east of the church and on the lower terrace.

Three further residential dwellings have been presented so far at Ajdna, apart from the church. They were all covered with roofs and now serve as shelters for visitors. The church was presented to such an extent that it can again serve its original purpose. It can be said that people took to it: church services are held there at least twice a year. In the church entrance the history of the settlement, its discovery and restoration are presented on six boards. Plans were made for the display facilities of other buildings, and the expert commission confirmed them. The decision reached by the commission was that further excavations of the entire settlement would irreparably destroy the exceptional ambience at Ajdna, therefore the investigations were stopped at the present stage. The restoration works are taking place on the lower terrace at present. The surrounding area of the structure with a tank should be archaeologically researched. The excavations will not reach the edge of the terrace so as not to damage the border of the forest and consequently initiate erosion.
