Church of St. Pancras

IRN 694

Location	Stari Trg near Slovenj Gradec
Time of origin	11th–18th century
Time of restoration	1986–1999
Chief Conservator	Janez Mikuž, Svjetlana Kurelac and assistants Bine Kovačič, Alenka Horvat
Visits	The church is closed, the keys are available at the nearby Slemenik farm on Grad or at the rectory of the church of St. Radegund in Stari Trg.

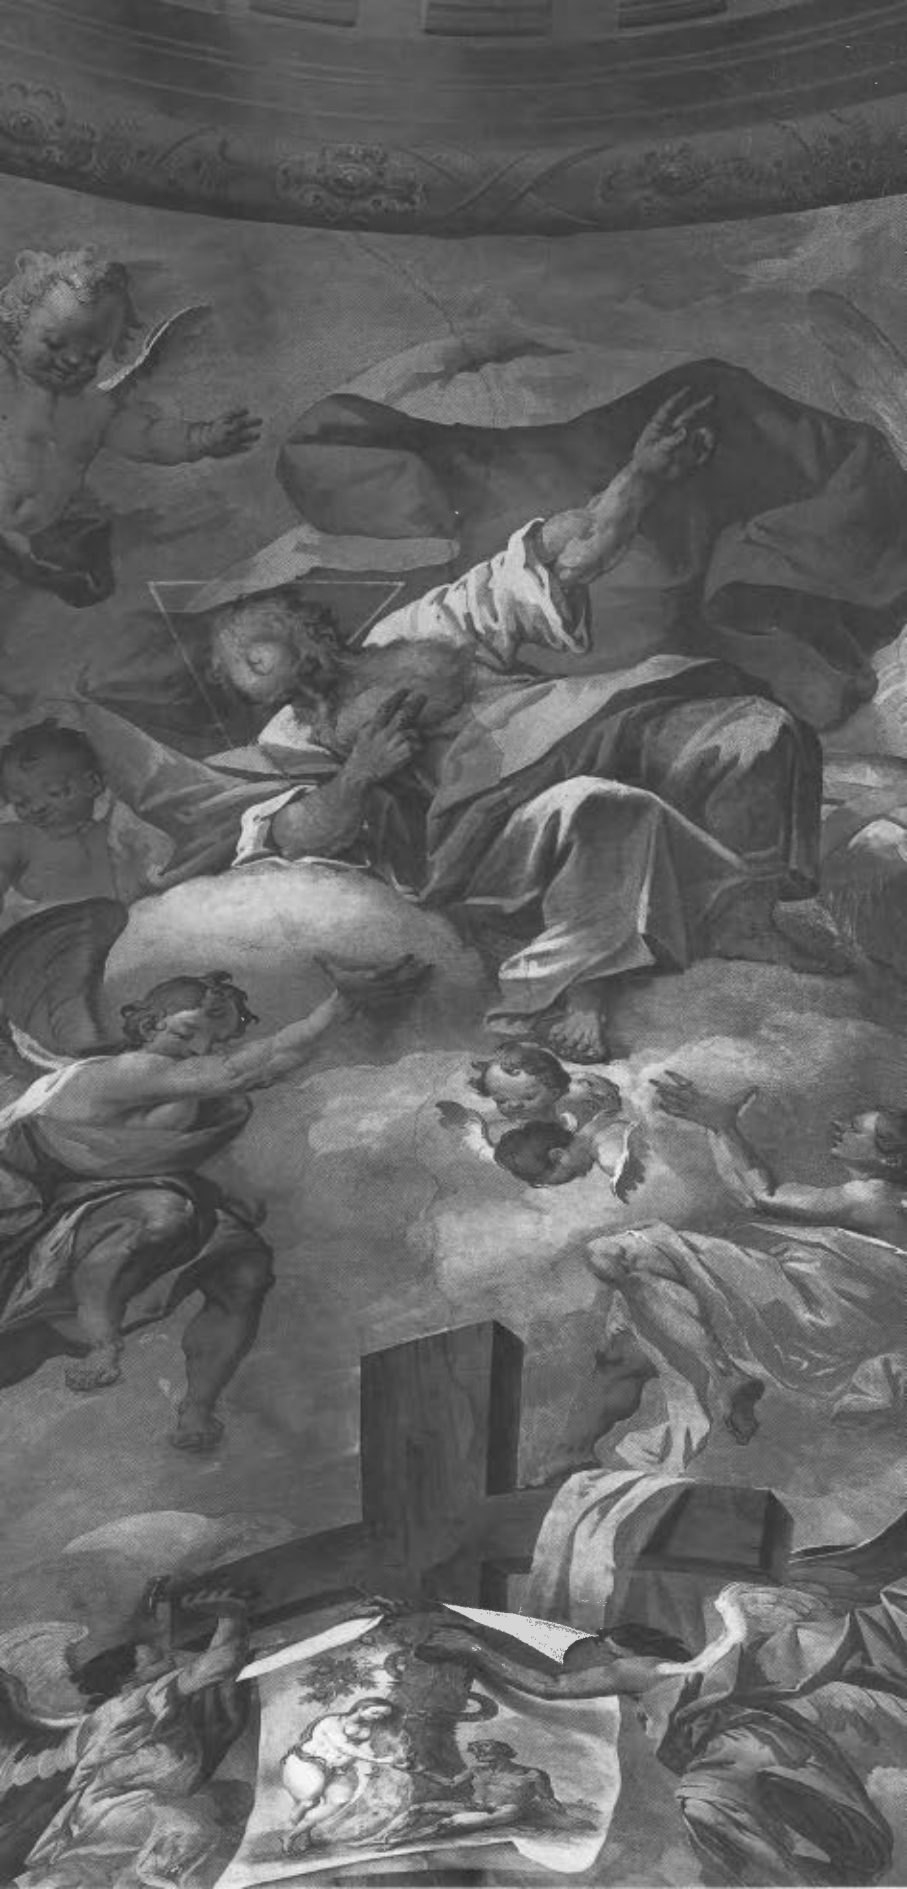
◀ Anton Lerchinger, detail of the painting in the dome of the holy stairs. “The holy stairs leaned on the exterior of the building, thus concluding the Stations of the Cross...”

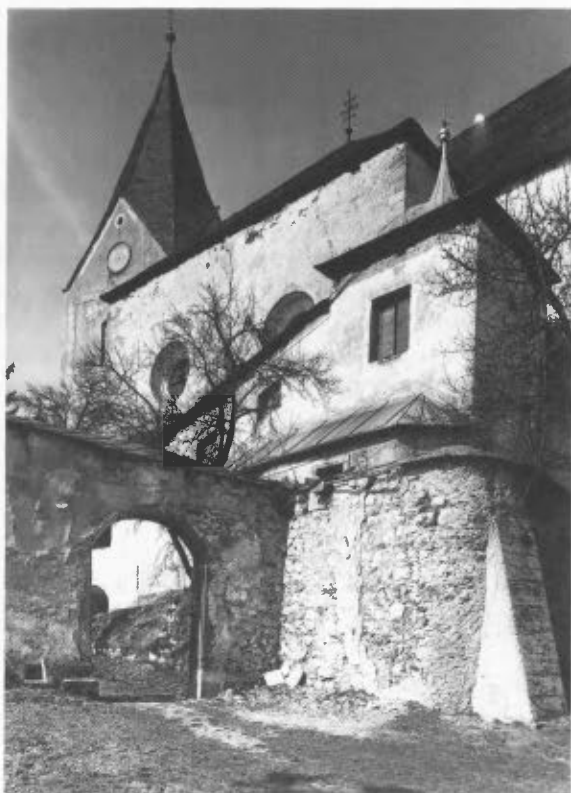
The church before the renovation in 1977. “The condition of the monument complex was critical particularly as far as the construction was concerned...”

The condition of the monument complex was critical particularly as far as the construction was concerned, and its expressive quality was seriously curtailed primarily on account of inappropriate interventions. Sparse conservation works in the past were never finished and were performed without thorough knowledge of the historical substance of the building.

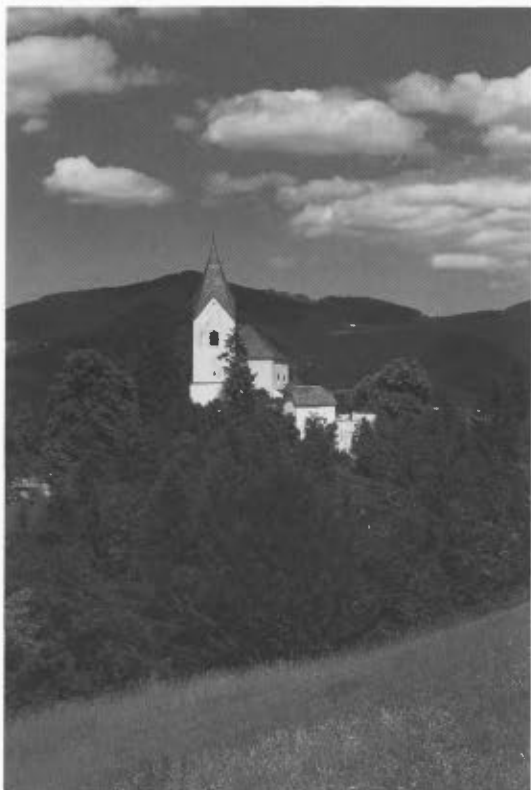
View of the renovated church. "During the works no new evidence of the history of the building was discovered so as to facilitate solving the enigma of this unusual mediaeval architecture..."

Plasterwork on the external facade was renovated on the basis of surveys. During the works no new evidence of the history

of the building was discovered so as to facilitate solving the enigma of this unusual mediaeval architecture.

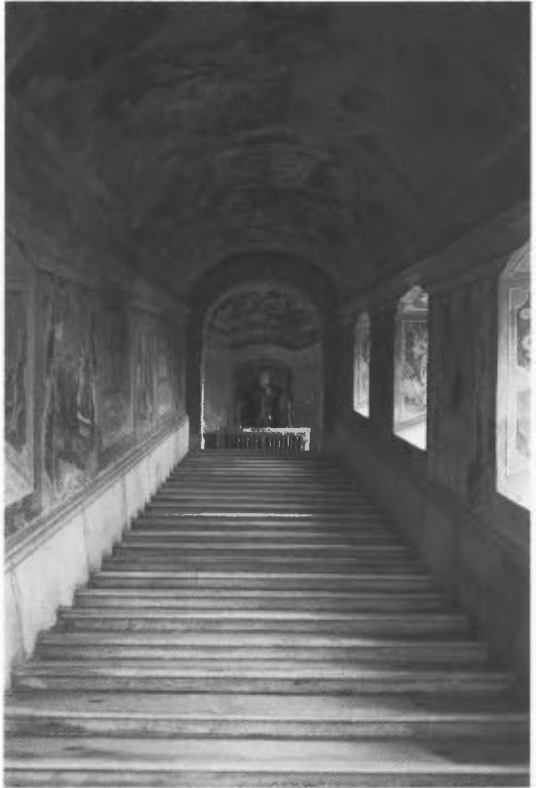
The church of St. Pancras had undergone the greatest transformation during the Baroque period. A large presbytery was added to the uniform space of the chapel of Berthold the Patriarch. The holy stairs leaned on the exterior of the building, thus concluding the Stations of the Cross leading across the slope from the church of St. Radegund in Stari Trg. The vault of the staircase was painted with scenes of salvation and victory over sin. Scenes of the passion were depicted on the walls. The

frescoes were painted by the Baroque painter Anton Lerchinger in the seventies of the 18th century.

The holy stairs. "The frescoes were painted by the Baroque painter Anton Lerchinger in the seventies of the 18th century..."

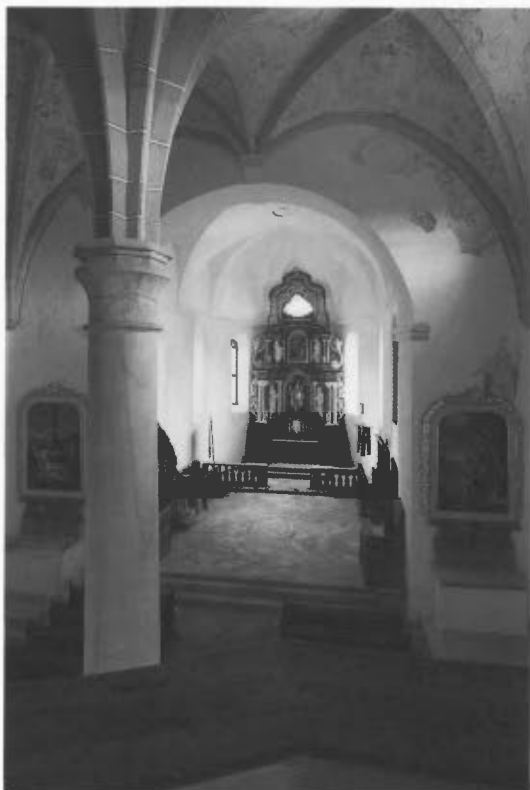
View from the nave to the presbytery. "The church of St. Pancras had undergone the greatest transformation during the Baroque period. A large presbytery was added to the uniform space of the chapel of Berthold the Patriarch..."

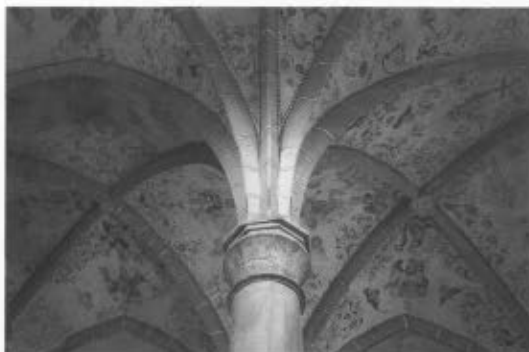
The plaster on the walls of the nave and particularly on the ceiling had moulded in several places due to the leaking of the roof. Subsequent wall paintings were executed in the secco

Detail of the painted vault in the nave. "Figures of saints and busts of angels were painted among creepers and flowers covering the entire fields of arches in distinctive yellow and violet shades..."

In the process of restoration and presentation the appearance of the painting on the ceiling became discernible again. Figures of saints and busts of angels were painted among creepers and flowers (floral ornaments of stylized vegetation) covering the entire fields of arches in distinctive yellow and violet shades. The repetitive pattern of angel musicians with their instruments (the lute, flute, mandoline and harp) was dis-

technique, which produced a series of problems in the restoration: the physical opening of the paintings on the entire surface of the church, strengthening of hollow parts of the plaster with Casein glue, strengthening of coloured layers, filling the missing parts, and retouching. The same procedure was used for the ribs of the vault which were painted as well. The data gathered during the removal of the plaster were used for the reconstruction of the strip-shaped ornament executed in grey-white shades and burnt sienna. The removal of plaster on mouldings revealed remnants of polychromatism, yet insufficient for the reconstruction. An opening of an indefinite purpose was discovered in the north-western corner of the vault construction. It was subsequently closed and the plaster was deepened. There were no remnants of painting on the western wall, while there were clearly discernible traces of two rectangular openings. Another fresco of Mother of God in a frame made of coils was on the southern wall of the nave with

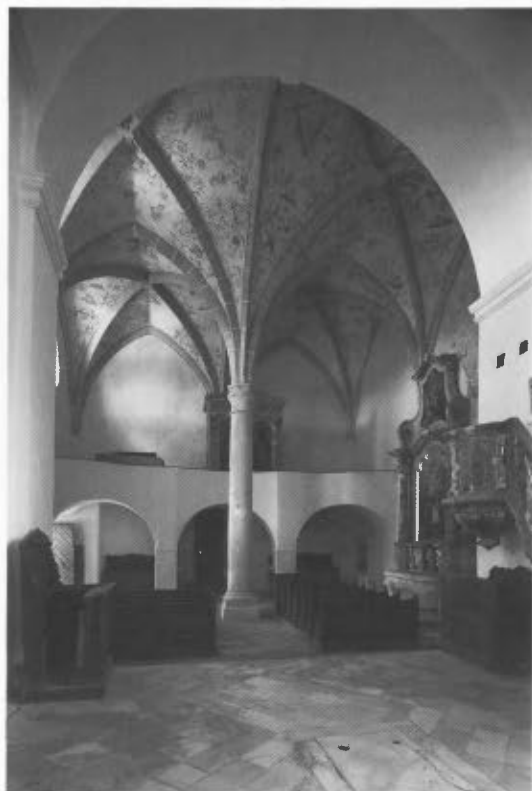
The volume of the monument erected around the year 1240 differed from most monuments in the same cultural area created during the Romanesque period that were subsequently taken over and adapted in the Gothic style. Attention is drawn particularly to the central monolithic column as the bearer of the cross vault. A Roman column found in the ruins of the near-by antique settlement of Colatio was presumably used for

it. Most probably the column had dictated the disposition of this unusual building since it defined the entire space, and particularly the four fields of the cross vault. Dr. Marijan Zadnikar stated that churches with square floor plans and central columns as bearers of cross vaults were particularly numerous in the late Gothic period in Austria, yet they were distinguished from the church of St. Pancras by an essential characteristic: apart from the square nave they all had a separate presbytery, which was not the case with St. Pancras until the Baroque period.

Central column with the cross vault of the nave. "Attention is drawn particularly to the central monolithic column as the bearer of the cross vault. A Roman column found in the ruins of the near-by antique settlement of Colatio was presumably used for it..."
