## Lime-kiln in Kamna Gorica

IRN 8786

Location	Ljubljana
Time of origin	1895
Time of restoration	1993–1995
Chief Conservator	Aleš Florjanc with assistants Dr. Anton Ramovš, Irena Vesel-Kopač

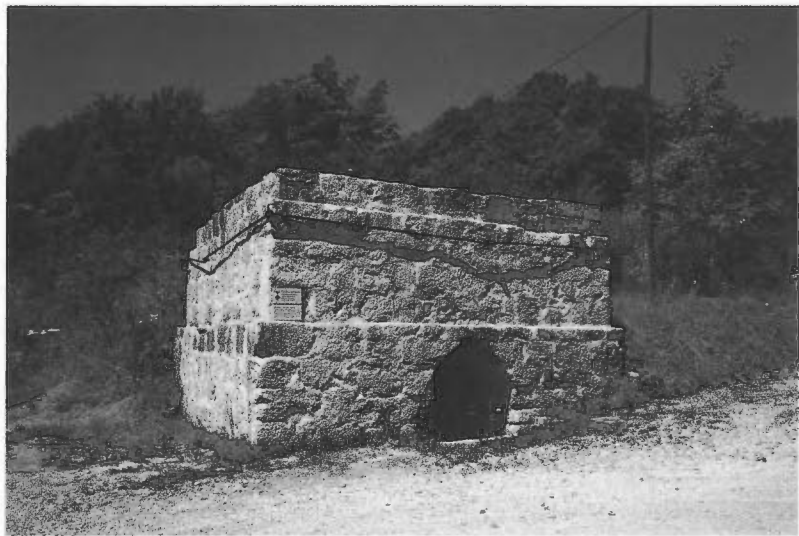
The lime-kiln was filled with rubbish. It was also filled with superfluous earth all around, so that access to it was obstructed. The fill was probably a remnant of extensive excavation work for the construction of a local road.

Renovated lime-kiln in Kamna Gorica. "Strong and thick bushes have overgrown the lime-kiln and its surroundings. A tree grew out of this lime-kiln as well..."

Urgent restoration works on the lime-kiln were performed in 1995. The kiln was strengthened by additional stone blocks so as to prevent further dilapidation of the structure. The surrounding area of the monument was cleared and basic equipment for its public presentation was installed.

The square ground plan of the lime-kiln and the stone blocks on the top formed according to it facilitated the fabrication of a completely concealed ferro-concrete slab. This was necessary in order to bind the two separate layers of the lime-

kiln: the internal pot made of silica sandstone and the external wall made of blocks of clay limestone.

The external wall was built of extremely large stone blocks, therefore it was impossible to mend the damaged grout with cement. It was more practical to fill the large holes with smaller pieces of quarry stone.

The bottom of the lime-kiln was cleared to the level of the external terrain and the fireplace was reconstructed with baked brick in its original form. The badly damaged stone vault above the entrance was mended with new ashlar of indigenous clay limestone.

A grate with a suitable grid and rod thickness was installed on top of the lime-kiln so as to enable visitors to have a safe view of the kiln. The entrance was protected by a door in the form of an iron grate.
