Monument to Dr. France Prešeren

IRN5109

<i>Location</i>	Glavni Trg in Kranj
<i>Time of origin</i>	1952
<i>Time of restoration</i>	1998–1999
<i>Chief Conservator</i>	Renata Pamić

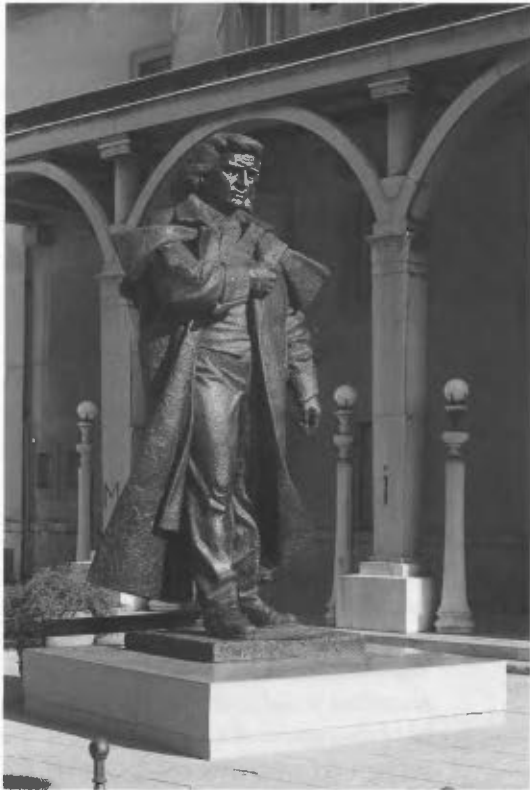
The statue has withstood the ravages of time with the acquired patina; however, several areas of damage in the stone and rifts in the

bronze have gradually been revealed. Consequently, the monument was structurally endangered and posed a threat to visitors. Kranj Town Council and the Institute for the Protection of the Natural and Cultural Heritage of Kranj renovated the monument completely in 1998 and 1999. Endoscopic and technoscopic tests revealed that the statue was standing merely on its legs without any additional support. The bronze was badly cracked in critical places. Water leaked between the base plate and the pedestal so that the juncture of the base plate, stone block and holdfast was loosened by water and ice. A detailed plan of the rifts

An analysis revealed that the sculpture was made of several casts that were welded together. Only the legs of the statue were filled with concrete, thigh-high. The bronze was severely cracked in those parts. The rift on the right thigh was particularly bad. The right leg thus functioned as the support for the vertical load or weight of the statue, but not for horizontal loads like a gust of wind or shock of an earthquake. The left leg, practically without any cracks, was the only part that afforded stability to the statue. Water was accumulating inside the statue due to the porosity of bronze, and deformations and rifts occurred in winter due to ice. There were further cracks on the top of the head, on the arms and in the lap of the statue. Complete insulation was practically impossible, therefore drainage was provided in the new base.

The statue was cleaned by microsanding, renovated and re-coated with patina. It was strengthened from the inside and braced to the bronze plate that was strengthened as well and fastened to the new granite pedestal. A weeping willow was planted behind the monument and three maple trees in the line of the theatre arcades. The vicinity of the monument, or rather the square, was fenced in with metal posts. The plan for the improvement of the monument and the horticultural landscaping was prepared by the Institute for the Protection of the Natural and Cultural Heritage of Kranj. The name of the poet and a verse from his poem "Zdravljica" were inscribed in gilded letters on the front of the pedestal.
