## Three Bridges

<i>IRN</i>	398
<i>Location</i>	Ljubljana
<i>Planning</i>	1927-1931
<i>Construction</i>	1842, 1930-1931
<i>Architect</i>	Jože Plečnik (in association with Ciril Tavčar and Janez Valentinčič)
<i>Renovation</i>	1991-1992
<i>Chief conservators</i>	Gojko Zupan, Staša Blažič

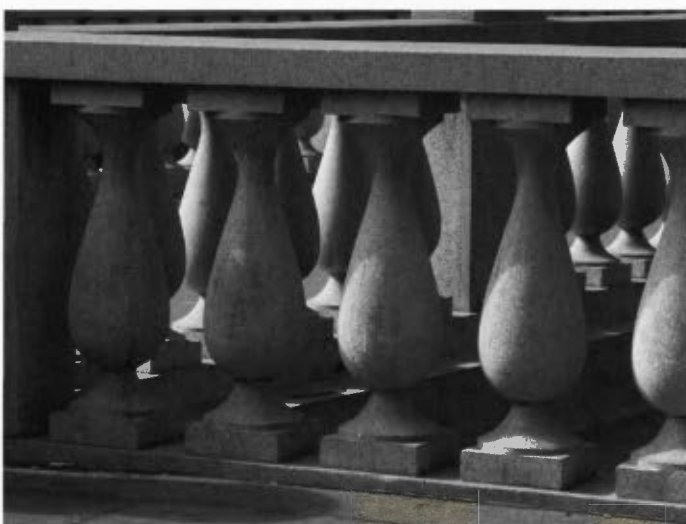
Handmade balusters on Three Bridges

renovation, they sought the advice of the appropriate experts. Since all balustrades were extensively damaged, it had to be decided whether to repair them or to resort to a more radical procedure demanded by traffic and statics experts. It was established that the original balusters could not be repaired – because their surfaces were too corroded – such that they would technically and artistically resemble the forms from the 1930s. They were fixed with weak, insufficiently long metal pins that were rusty and contributed to the internal deterioration of the individual elements. Some of the balusters were fixed to the ground only with mortar. But according to security regulations, the rail was supposed to prevent vehicles from falling into the river.

During preparatory work, a car hit the rail, knocking several balusters into the Ljubljanica; back in 1986 a lorry toppled a part of the rail itself into the river. Due to the delicacy of the project, the chief conservator proposed in 1990 a meeting of an expert committee that would supervise the renovation.<sup>2</sup> Additional material was prepared to this end. Plečnik's original plans were discovered. Detailed studies of different concrete mixtures for the bridges were made. The original moulds for the balusters had been discarded several years previous and could no longer be retrieved.

In the meantime, various companies made sample balusters. The most appropriate of these was presented by Coston. The committee visited the company several times to remedy any minor faults, to find the most appropriate mixture of materials and find the best polishing procedure for the decorative elements on the bridges. The new balusters appear the same as the originals, but they contain new, strong steel pins in their cores. The smooth appearance confused some experts who did not work with the committee. The preserved original balusters from the lower terrace and the area next to the public toilets had to be shown to them to mark the difference between their smooth surface and the rough and corroded balusters from the top of the bridges. The contractors replaced the rails and installed new bases for lamps. Despite the demands of the conservators, the concrete supports were not cast in one piece. Nevertheless, the renovation continued and was completed by the end of 1991. The wooden scaffolding used during the renovation of Plečnik's bridges was used for the construction of the new pedestrian bridge across the Ljubljana in the vicinity of Ribji trg (Fish Market).
